CONNECTICUT RIVER BASIN
HARRISVILLE, NEW HAMPSHIRE

HOWE RESERVOIR DAM
NH 00095

PHASE I INSPECTION REPORT
NATIONAL DAM INSPECTION PROGRAM

MAY 1979

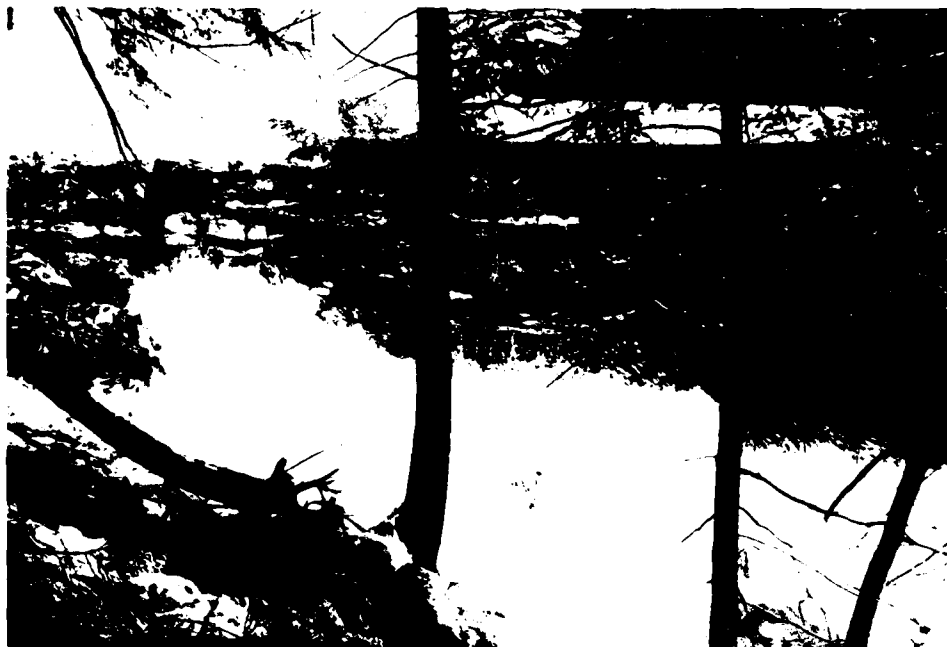
1. Overall view looking upstream.

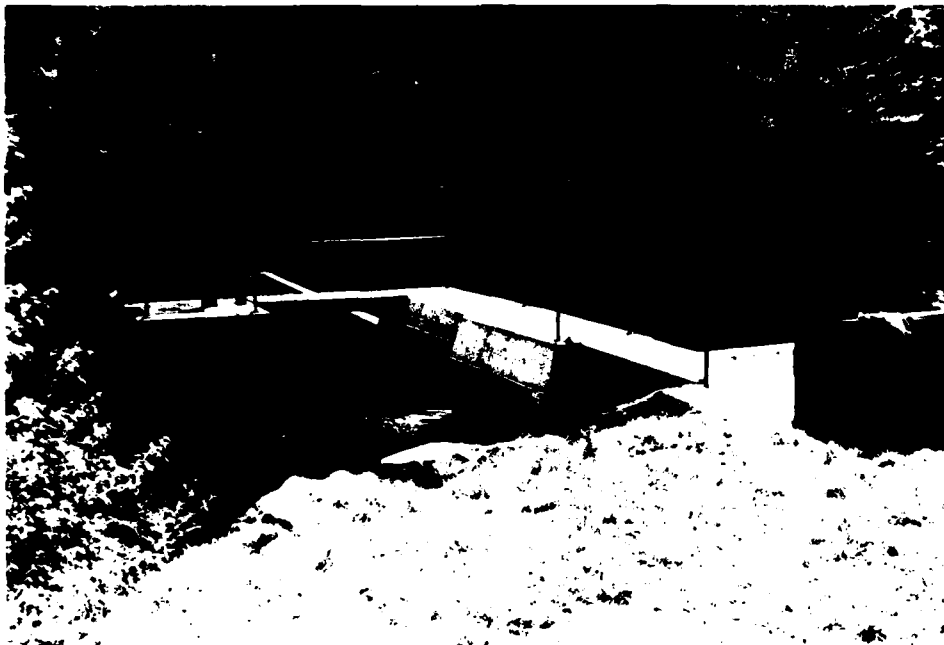
5. Intake structure, footbridge and sluice gates near the right abutment looking south.

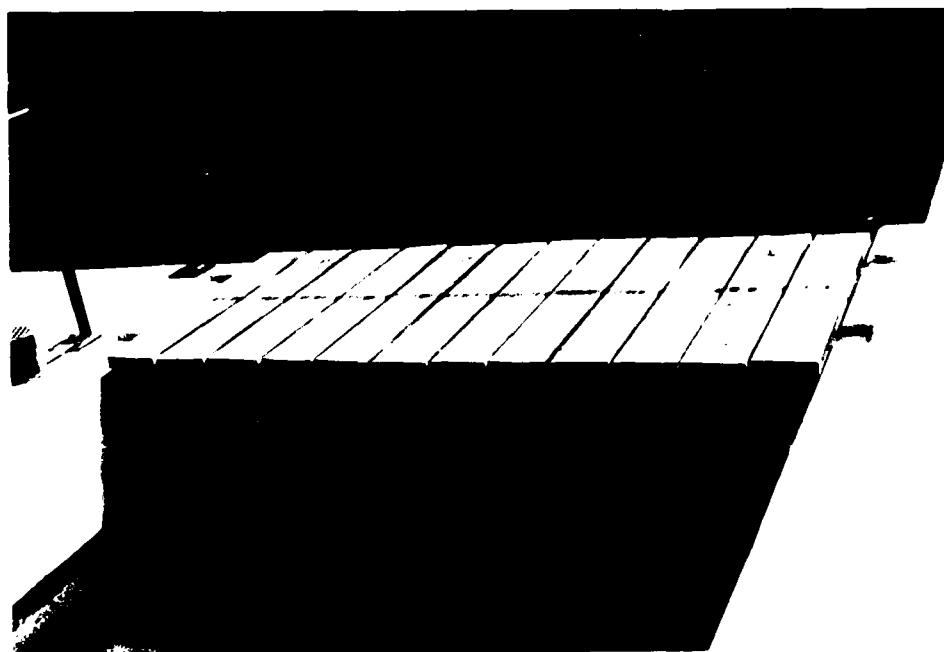
6. Footbridge from dam to the intake structure looking south.
